**Corrosion of Stainless and Carbon Steel in Aqueous Amine for CO<sub>2</sub>  
Capture**

**Dissertation**

**The University of Texas at Austin  
May 2019**

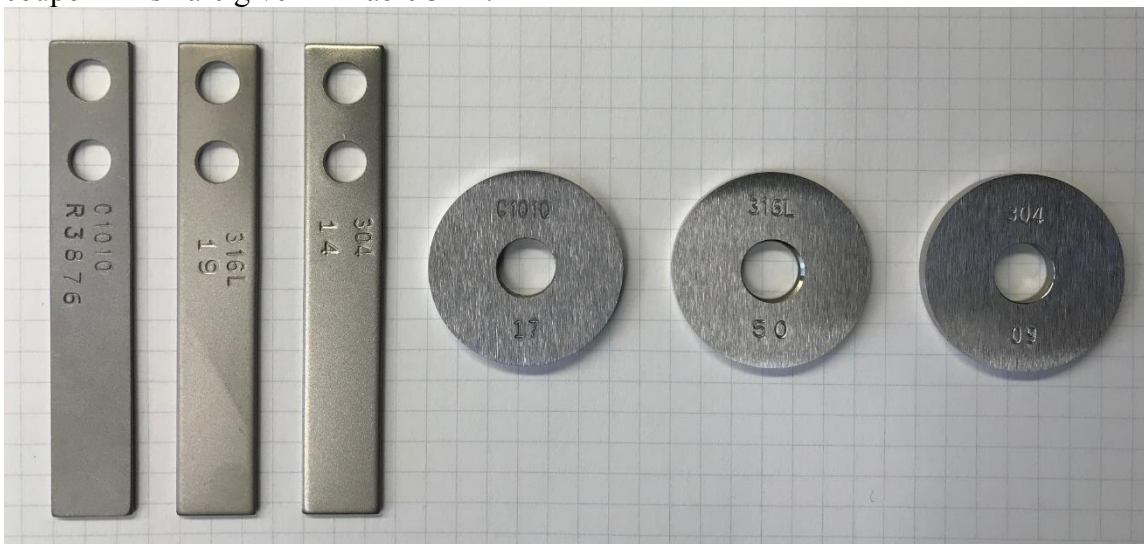
Figure 3-2: Blank coupons, from left to right: C1010 strip coupon, 316L strip coupon, 304 strip coupon, C1010 disc coupon, 316L disc coupon, 304 disc coupon.

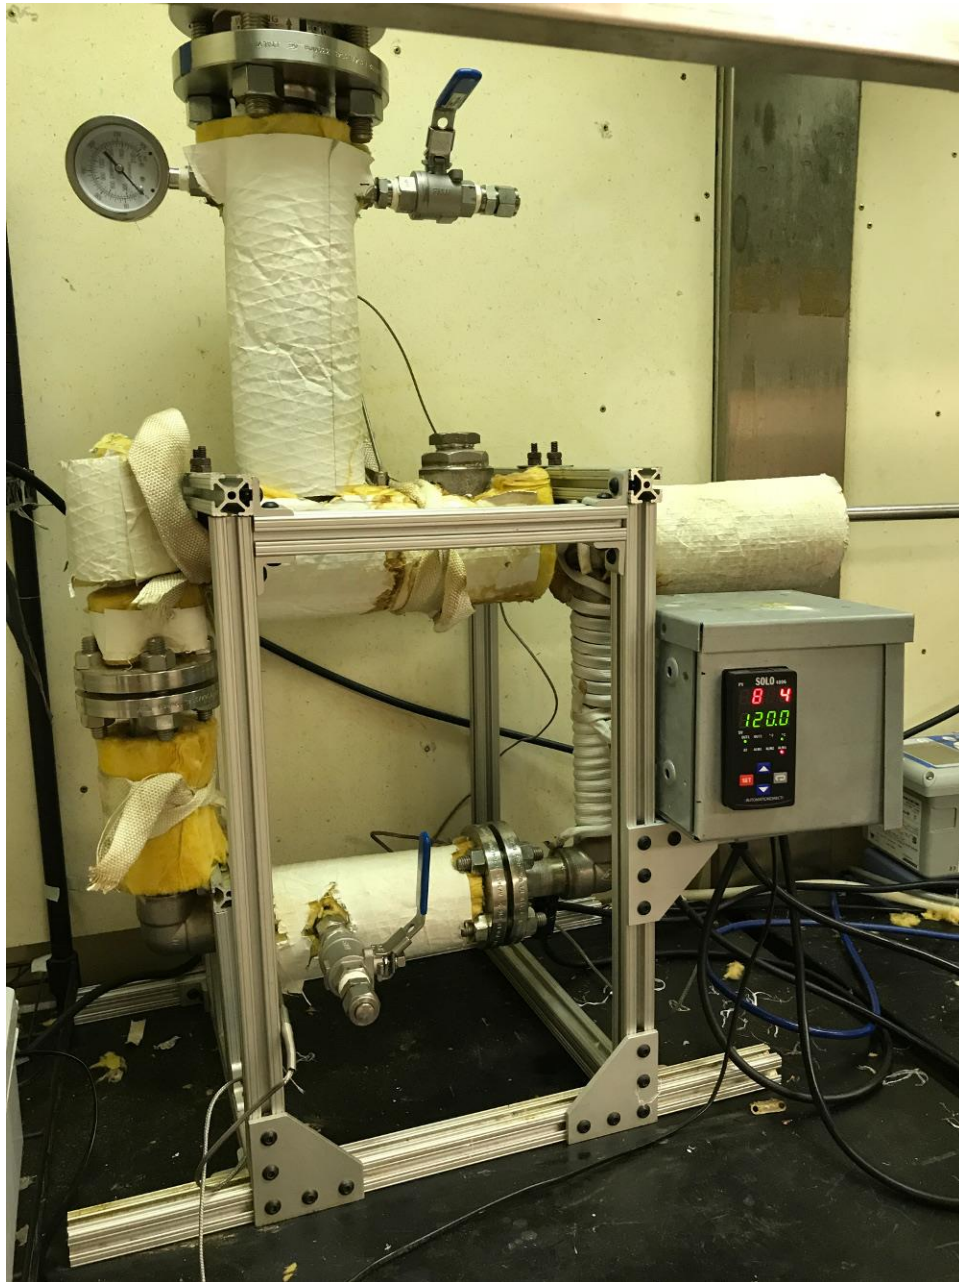
Figure 3-5: Corrosion loop apparatus, ORP probe not shown.

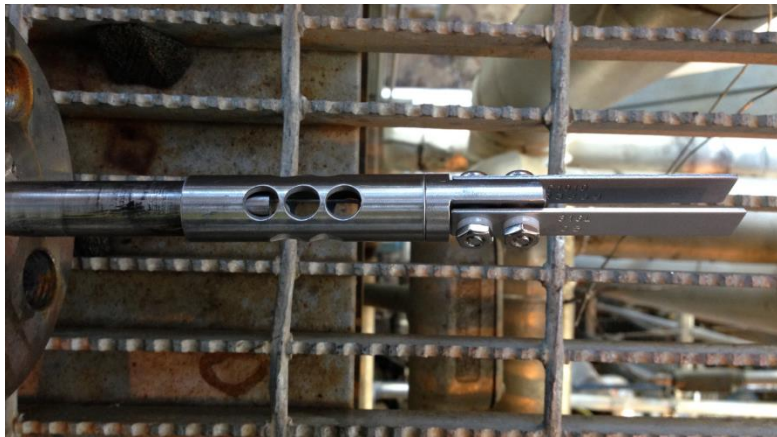
During several campaigns (SRP 2017 PZ, NCCC 2017 MEA, some locations in the absorber during NCCC 2018 PZ), coupons were mounted at ER probe locations. This is accomplished using a simple adapter that allows strip coupons to be attached to the end of ER probes. The coupon adapter is shown in Figure 3-9.

Figure 3-9: Coupon adapter for ER probes holding two strip coupons.

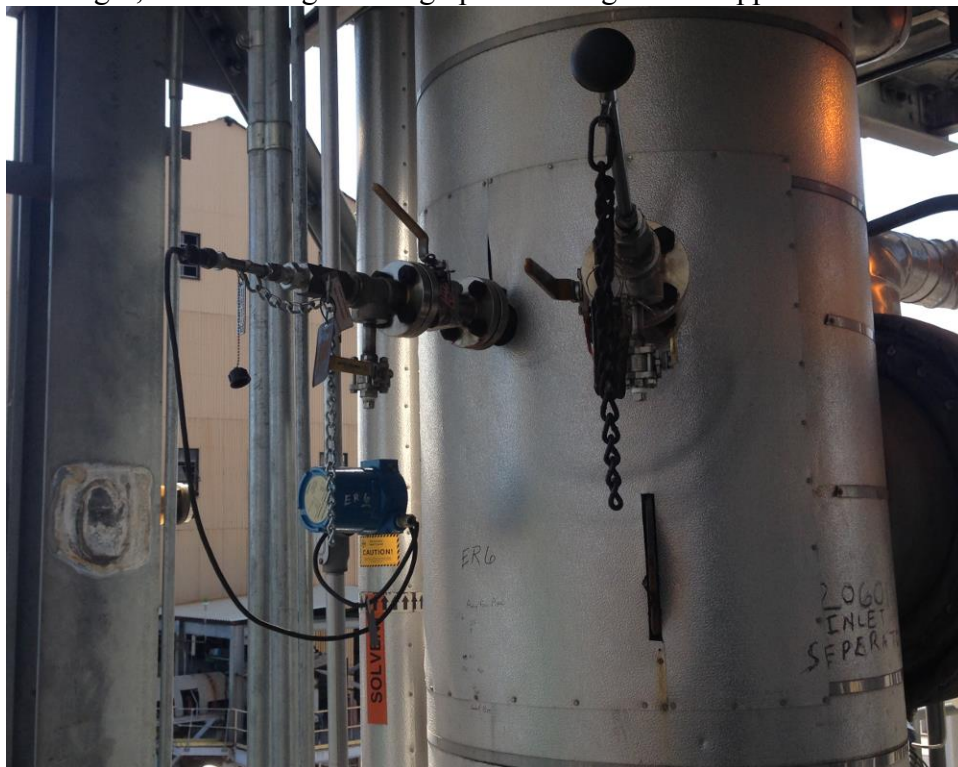
An ER probe and a coupon probe inserted into a process vessel at a pilot plant are shown in Figure 3-10. Both pieces of equipment can be retracted, isolated, and removed during plant operation. This is accomplished by retracting the probe through a compression fitting, then closing a process isolation valve, then depressurizing and draining the probe mounting hardware, and finally removing the probe. The procedure for installing a probe, pressure testing it, and inserting it during operation is given in Appendix A.

Figure 3-10: An ER probe and a coupon probe inserted into a vessel at a pilot plant.

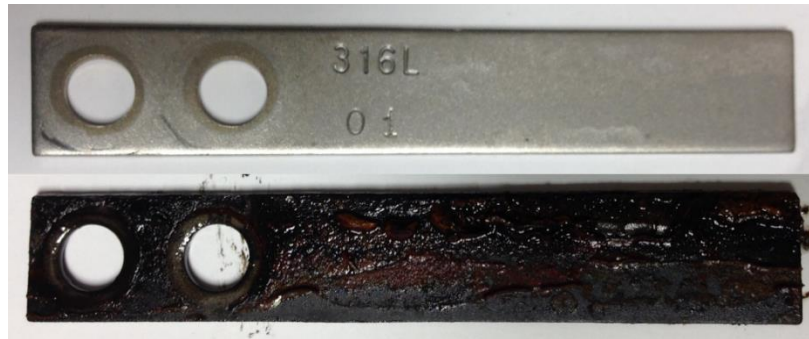
Figure 6-8 shows the appearance of the first set of hot, lean coupons immediately after removal and rinsing with deionized water. The 316L coupon is pristine, but the C1010 coupon is covered with a flaky, black and red film. Figure 6-9A shows the SEM micrograph of the C1010 red product, which is fluffy and porous. This product was identified as  $\text{FeO}(\text{OH})$  by powder XRD. Figure 6-9B shows the SEM micrograph of the C1010 black product, which is crystalline but patchy. This product was identified as  $\text{Fe}_3\text{O}_4$  by powder XRD.

Figure 6-8: 316L and C1010 coupons after removal from SRP stripper. Coupons experienced approximately 340 hours of water testing and 167 hours operating at temperature in PZ solution. Average  $\alpha = 0.21$ .  $T = 150\text{ }^{\circ}\text{C}$ .

Alloy	Location	Initial Mass (g)	Mass loss (g)	PZ Operation Time (hours)	Corrosion rate ( $\mu\text{m}/\text{yr}$ )	Mass of Corrosion Product (g)
C1010	absorber sump	10.7566	0.1879	320	312.2	0.0013
C1010	hot lean (batch 1)	10.4823	0.2752	167	878.2	0.0829
C1010	hot lean (batch 2)	9.5602	0.0275	152	96.4	0.0232
316L	absorber sump	10.5709	-0.0001	320	-0.2	0.0008
316L	hot lean (batch 1)	10.5863	0.0006	167	2.0	0.0004
316L	hot lean (batch 2)	10.1300	0.0026	152	9.0	0.0000

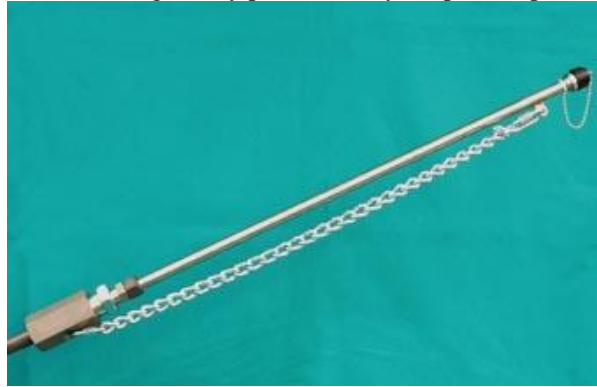
3. The ER packing gland consists of a packing body, a jam nut, a retainer, and a locking nut. The compression fitting seal is formed by the tightening of the retainer into the packing body, which compresses a Teflon fitting inside the packing body. The jam nut is a secondary fitting that prevent the retainer from being loosened by vibration. The locking nut is another secondary fitting that prevents the insertion rod from being slowly pushed out by the process pressure.

4. A safety chain is used to prevent the insertion rod from being pushed out slowly by the process pressure. The safety chain also prevents against accidental injury due to a blowout. A blowout may occur during retraction if retraction is performed improperly.
